historic structure report
the main building

ELLIS ISLAND
STATUE OF LIBERTY

NATIONAL MONUMENT/NEW YORK-NEW JERSEY

**Beyer Blinder Belle/
Anderson Notter Finegold**

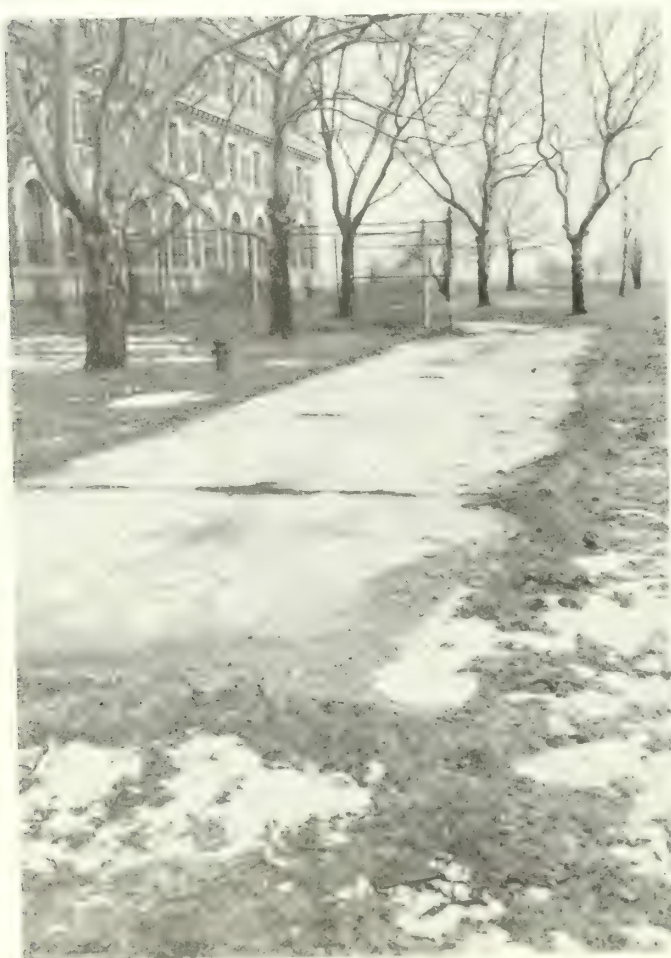
20. Concrete walk in poor condition.

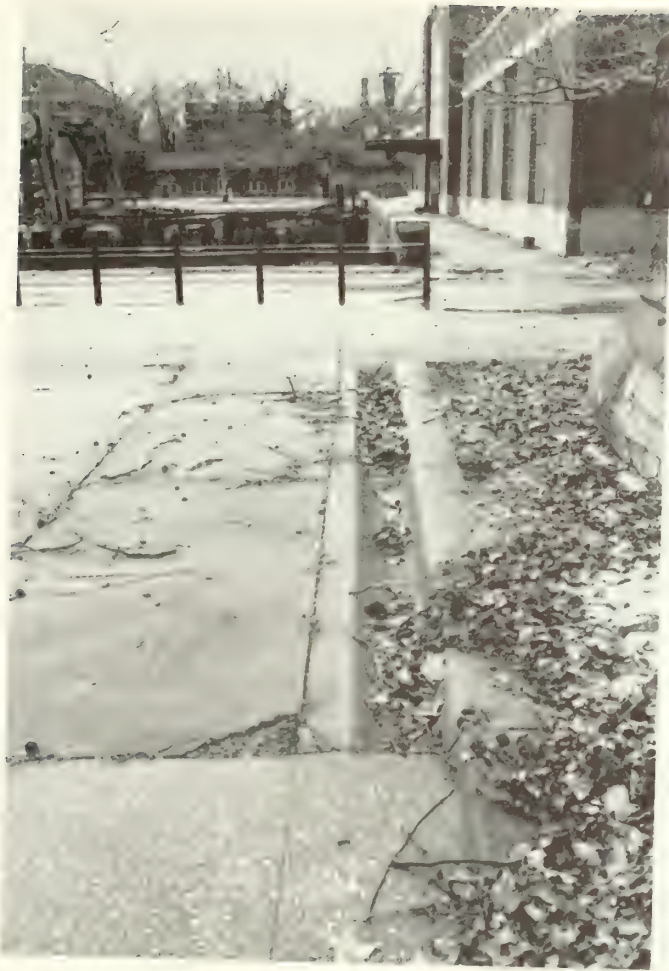
23. Concrete gutter, near western end of ferry slip.

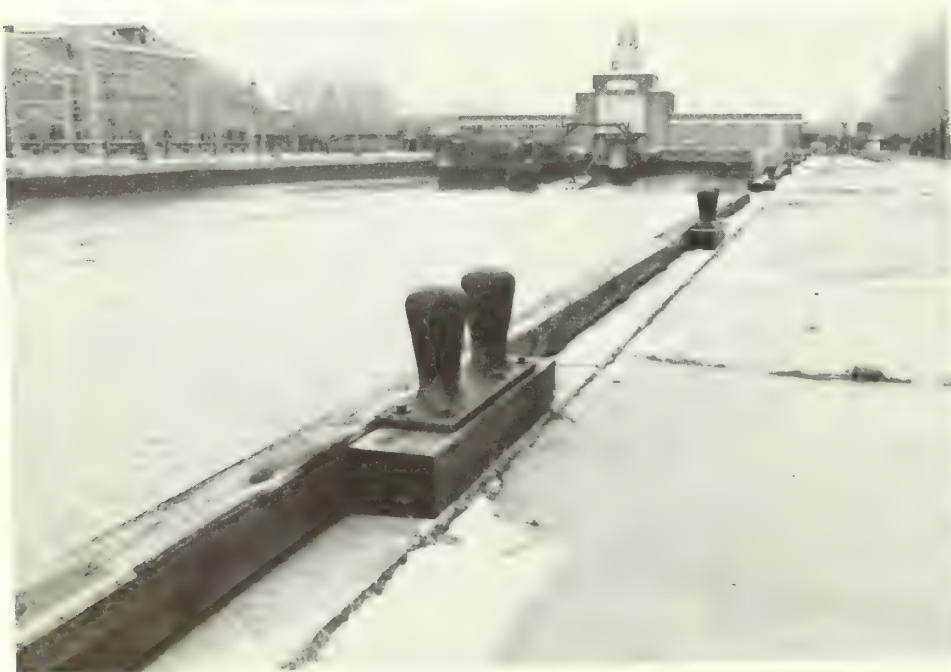
26. Bollards along ferry slip.

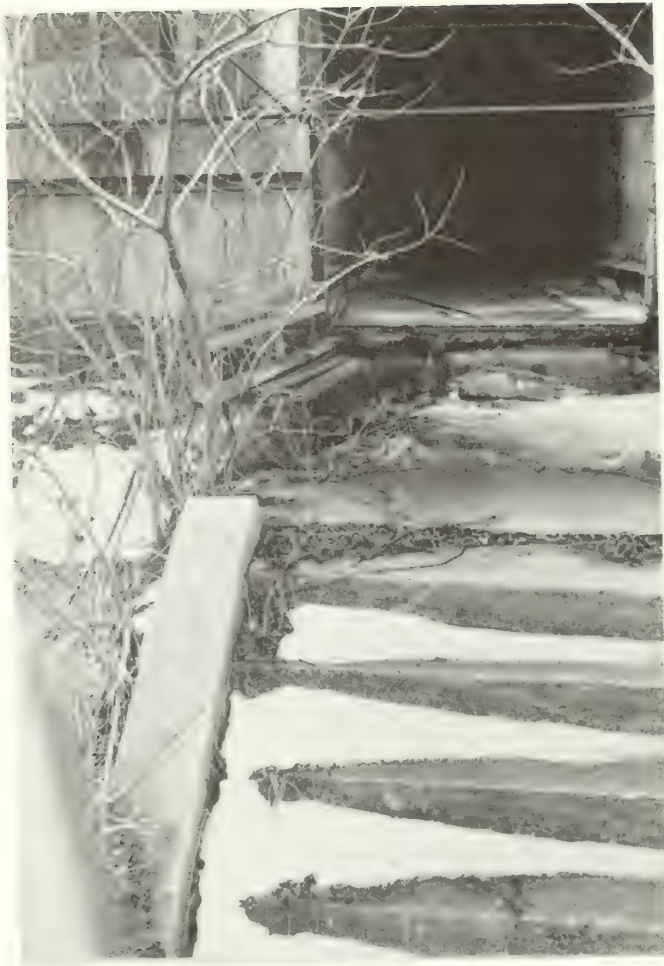
None of these benches is in good condition, but their metal support systems are intact and stable.

35. Bench found on the
doorstep of the
baggage and dormitory
building.

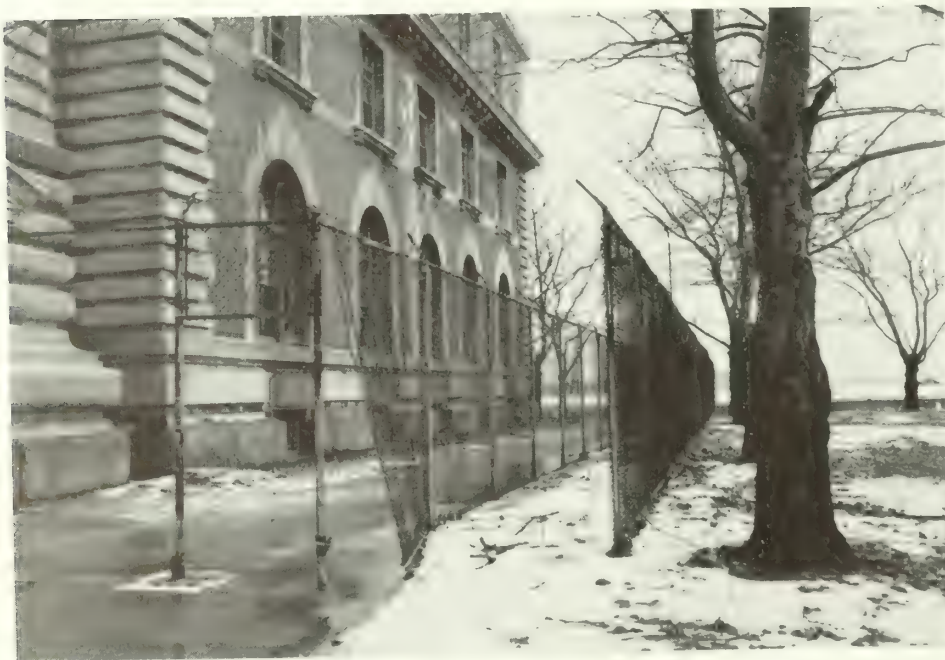
36. Chain link fence, in front of the east wing of the
main building.

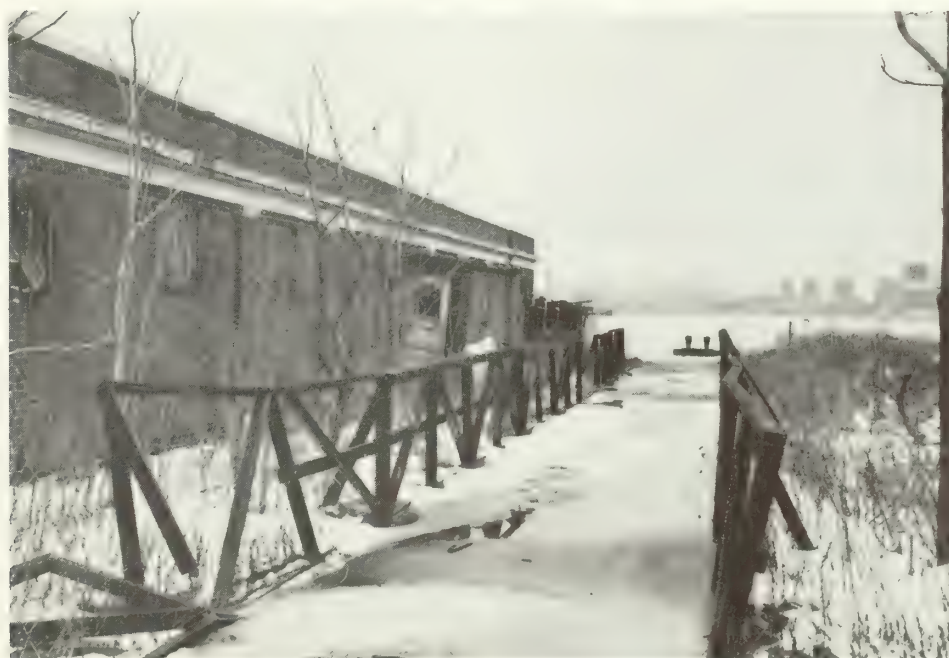
38. Wood fence between the powerhouse and the baggage and dormitory building.

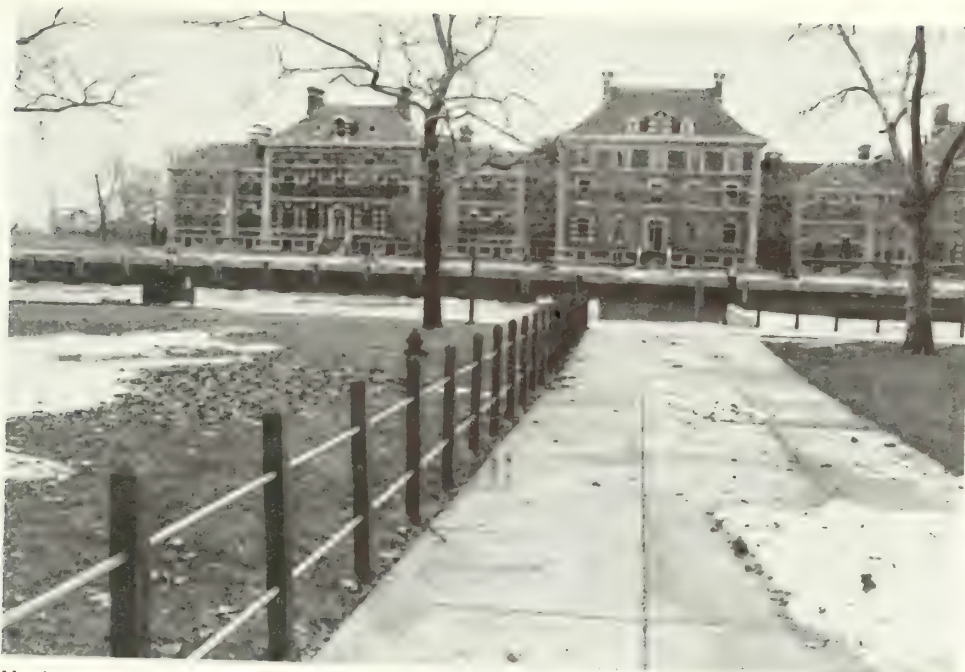
entrance to the main building (southwest) and along the bulkhead to the ferry building. This structure is in good condition (photo 39).

39. Modern NPS fence, front of main building.

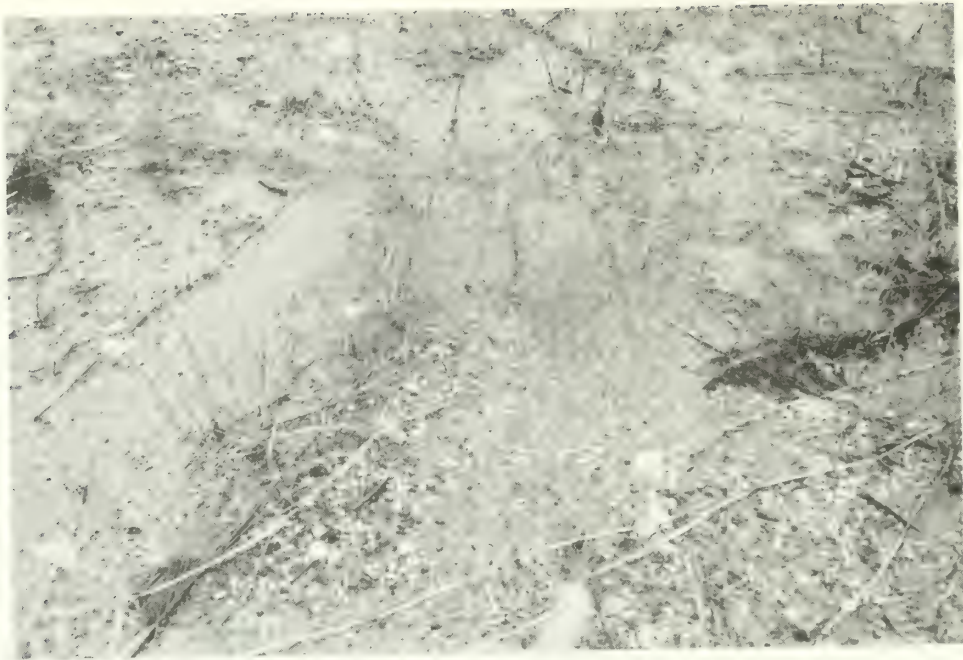
45. The 1935 landfill which is largely cinders.

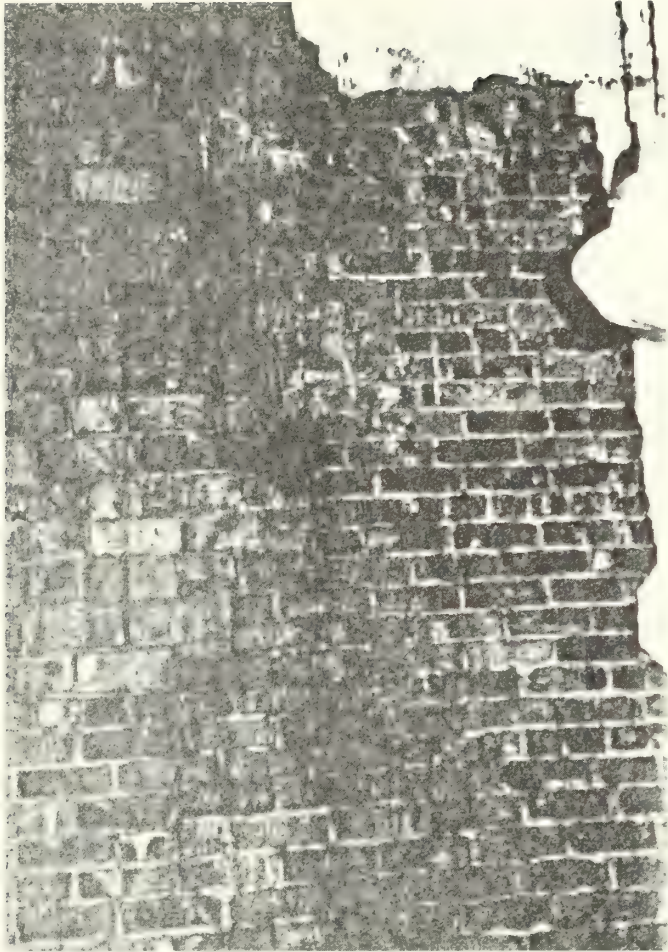
1. Interior crack, east wall, north end, third floor, main building

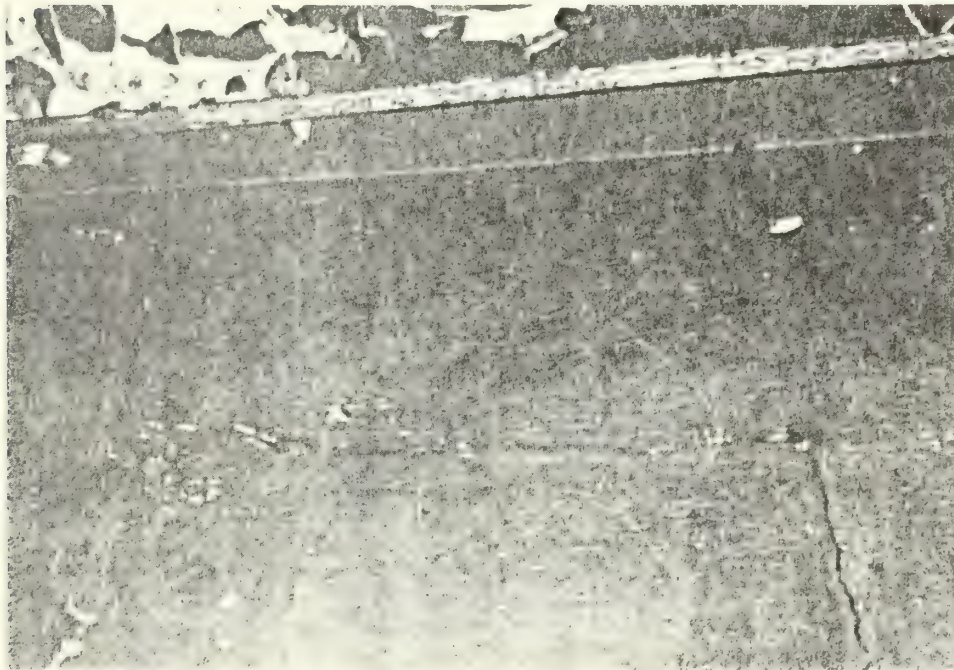
2. Interior crack, east wall, south end, third floor, main building.

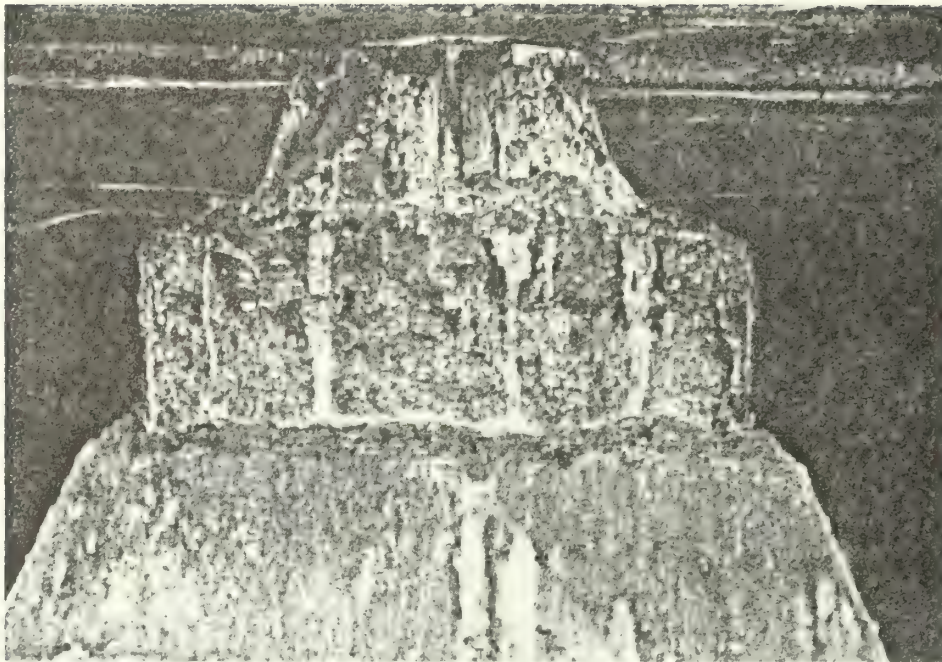
3. Footing, cap, and base plate, railroad ticket office.

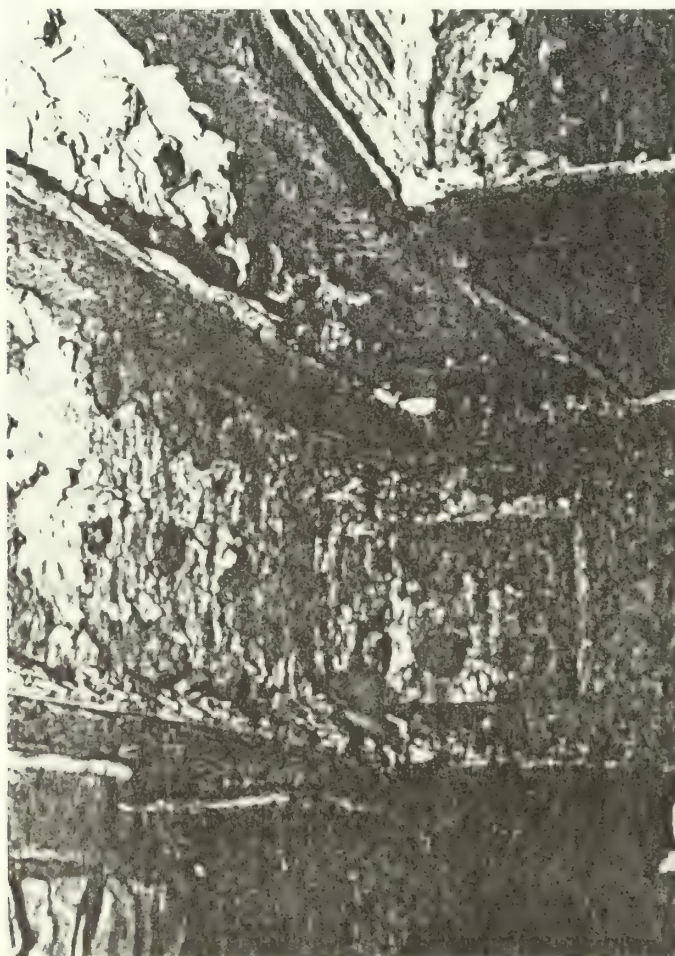
4. Steel deterioration at Column E-3, railroad ticket office.

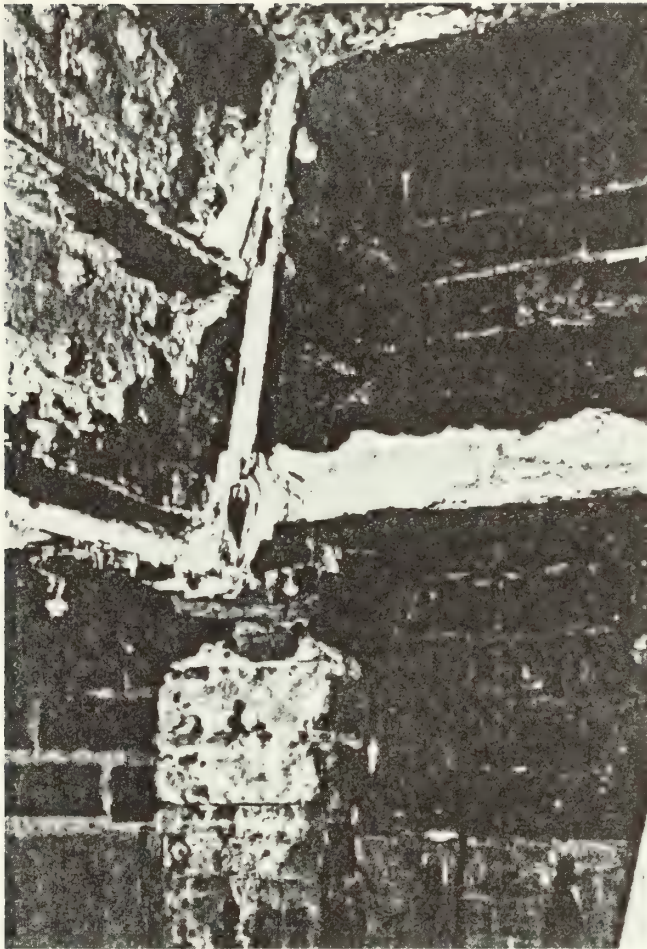
5. Steel deterioration at column C-1, railroad ticket office.

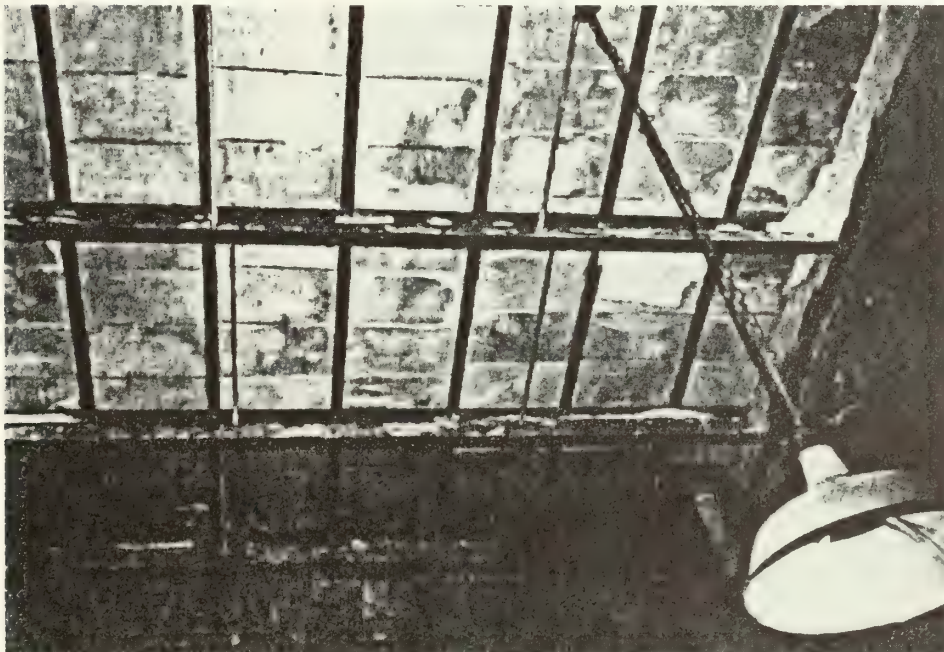
6. Roof steel deterioration, railroad ticket office.

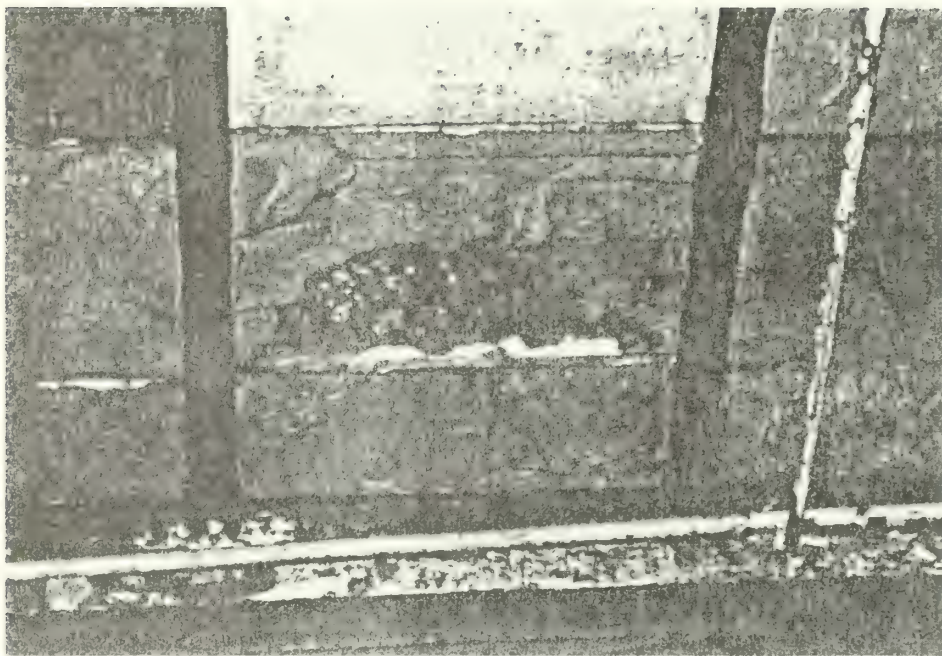
7. Clay tile deterioration, railroad ticket office.

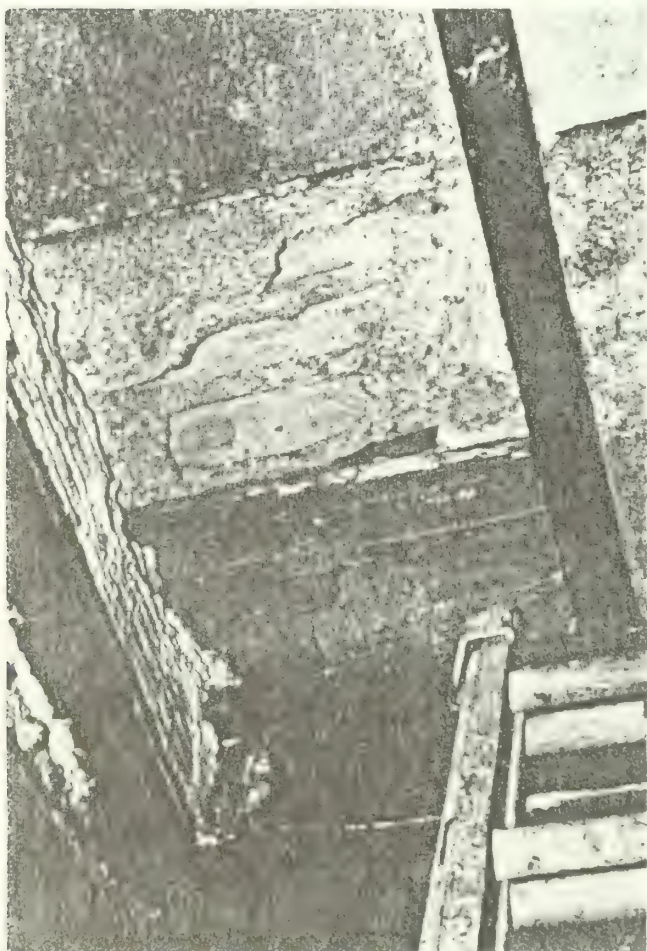
The 1'-0" x 2'-0" x 3-1/2" structural clay roof deck tiles have suffered water damage with the plaster coating falling away in approximately 25% of the roof area. In addition, the under surface of some tiles has spalled (photos 7 and 8). Other tiles are so badly deteriorated that they have fallen away (photo 9).

8. Clay tile deterioration, railroad ticket office.

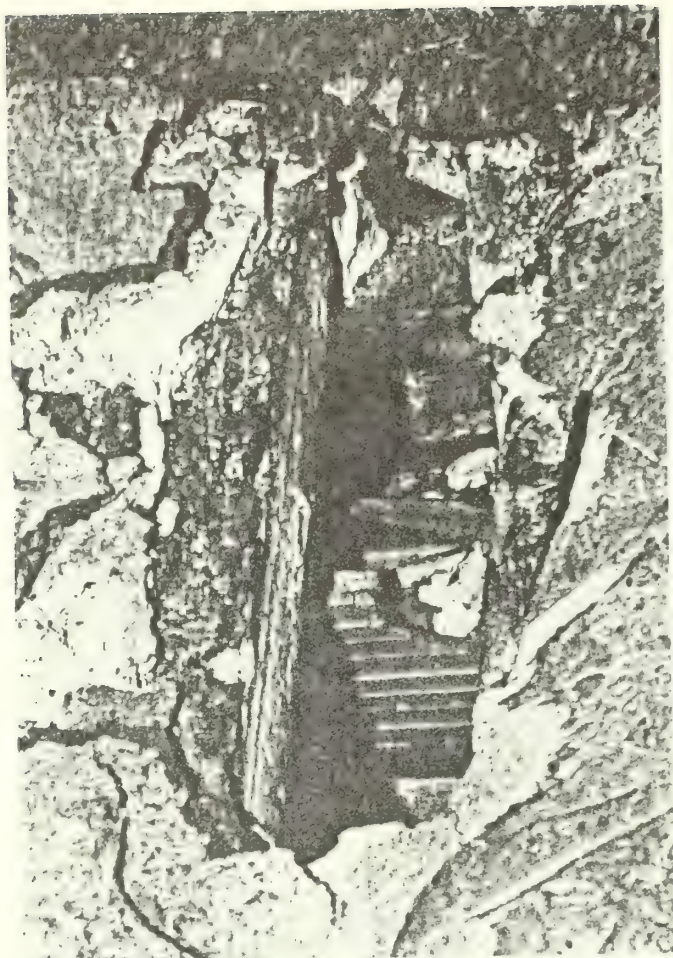
9. Probe hole No. 2, railroad ticket office.

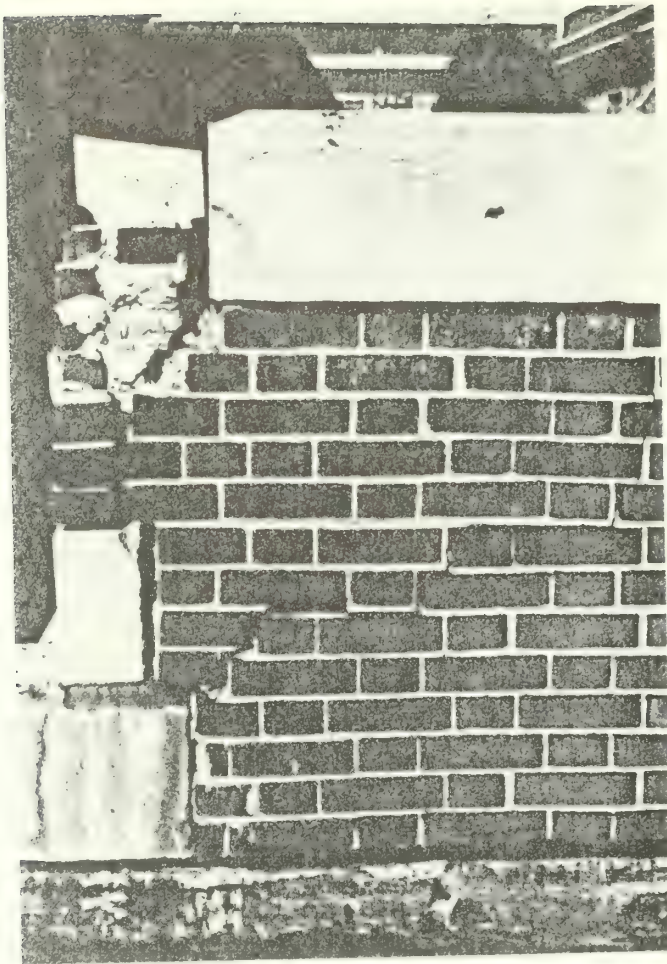
The parapet above the west wall, at the juncture between the ticket office and the vestibule of the baggage and dormitory building, has cracked at its north and south ends where it intersects with the east-west parapets (photos 11 and 12). This is due to thermal contraction of the railroad ticket office which lacks an expansion joint between the two buildings. Some deterioration of the wall inside the building under the parapet has occurred due to moisture penetration.

11. Cracked west parapet,
south end, railroad
ticket office.

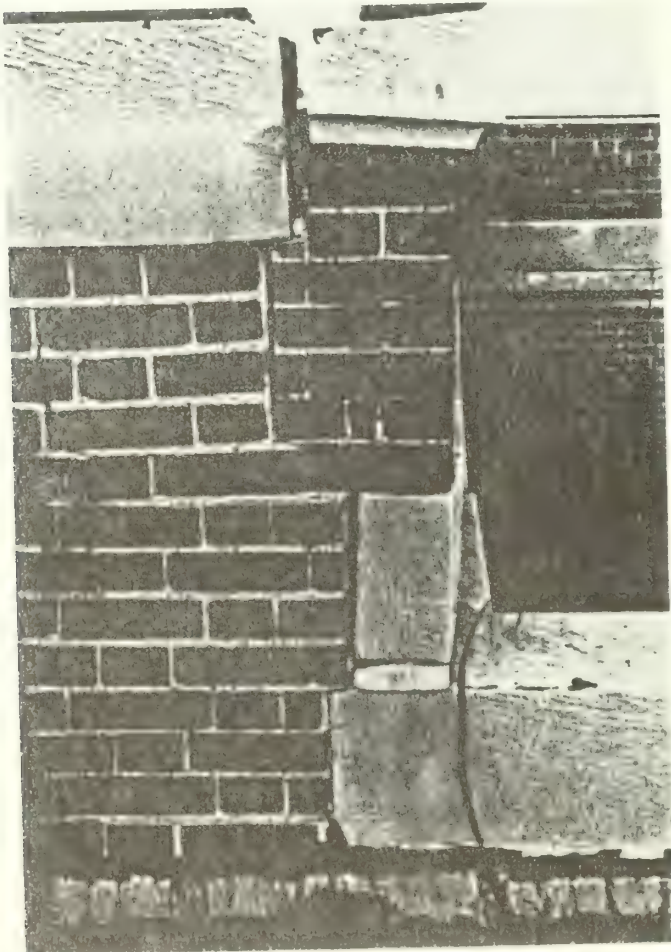
12. Cracked west parapet,
north end, railroad
ticket office.

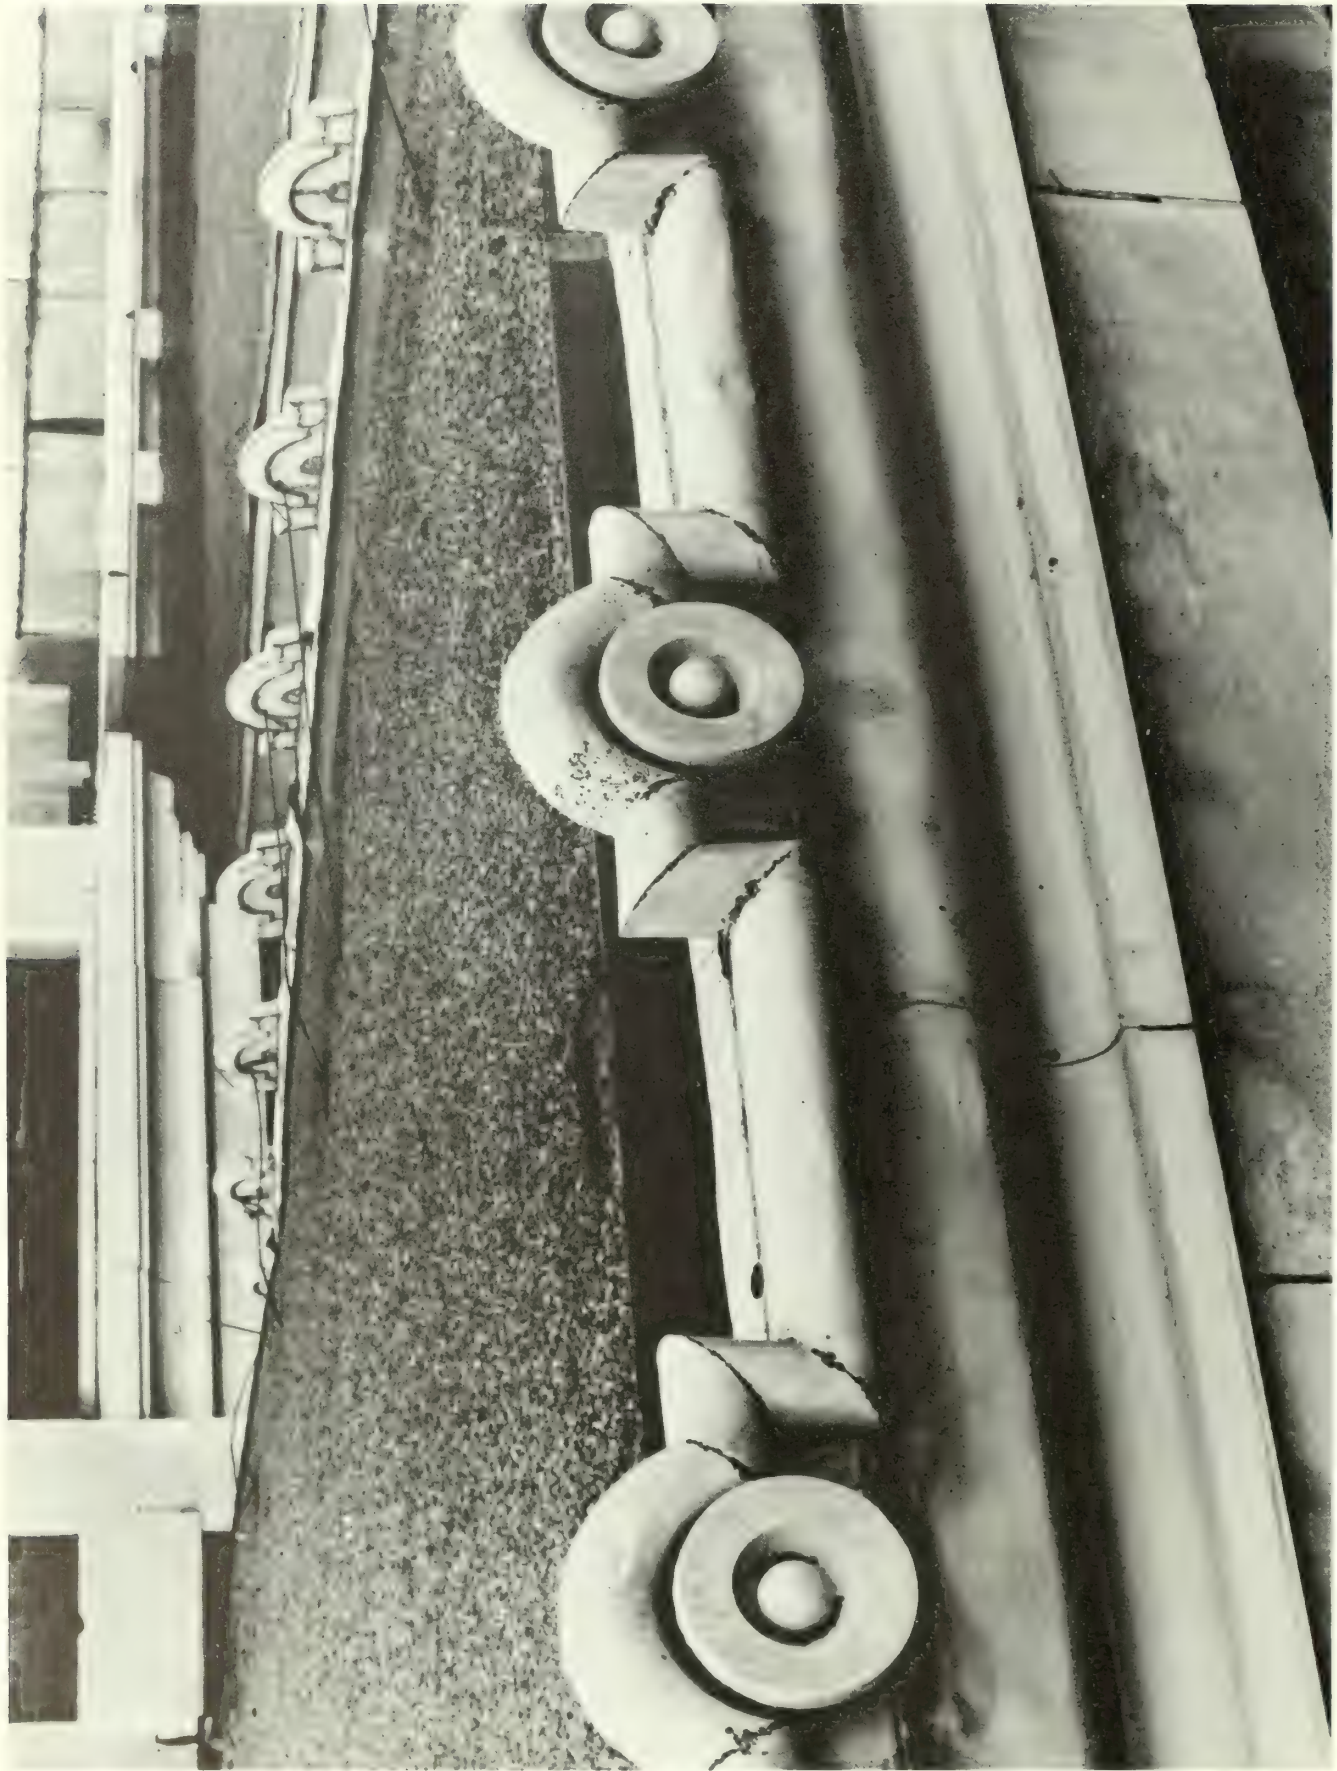
5. Original Ornamental Copper Cornices on Interior Gutters of Main Building Roof. Existing conditions;
Circa June, 1974.

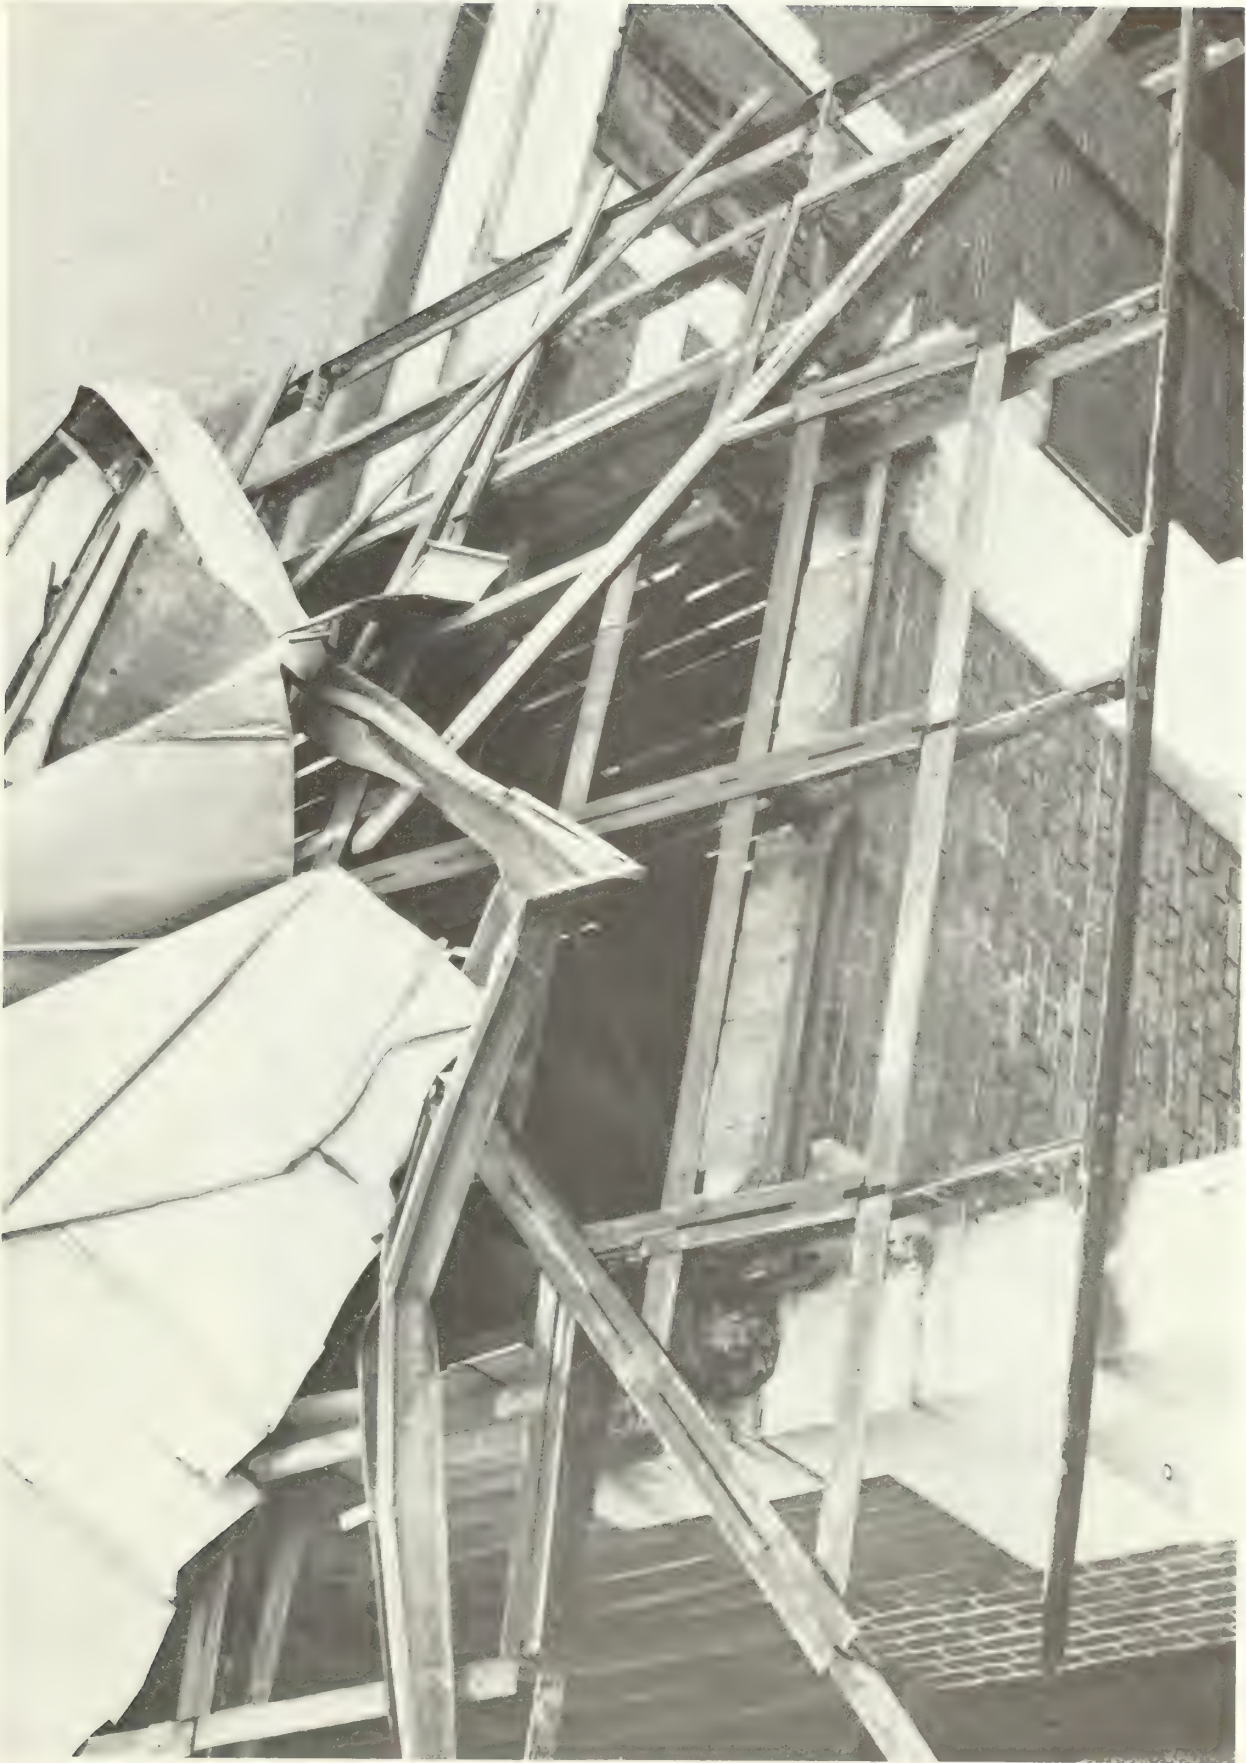
17. Steel framing for the Southeast Airshaft Roof, revealed during demolition and replacement with a new copper roof, 1977.
